RE: SOUTHWELL TOWN COUNCIL THE BURBAGE SOUTHWELL NG25 0EP

This report and quotation supersedes the previous report dated 7 December 2023.

Survey Date: 5th December 2023

Job No: 147398

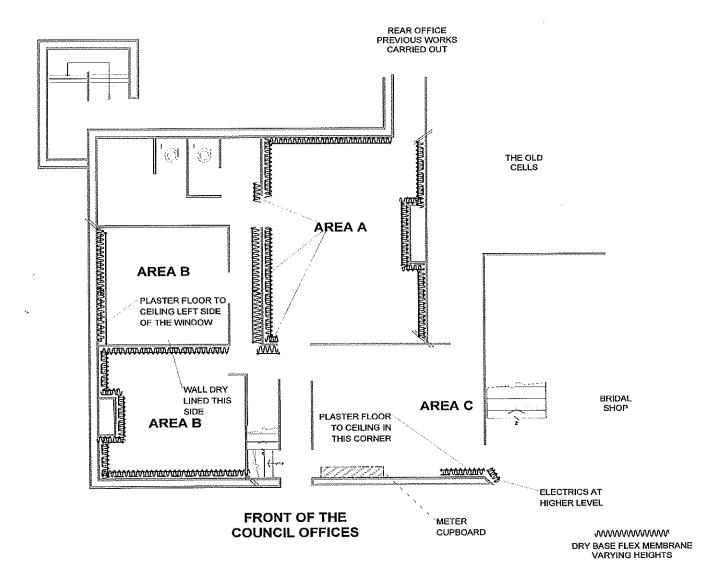
Further to our most recent site visit today 7th February 2024. As per your instruction that to undertake the works all in the one visit would cause too much disruption. We therefore have revised our quotation for dealing with the affected areas in stages to minimise inconvenience/disruption to the offices. There would be 3no visits dealing with areas A, B and C as detailed on the attached plan.

Our inspection internally revealed areas of spoiling of plaster and decoration, readings taken using an electronic moisture meter confirmed evidence of dampness to the walls as detailed on the attached plan, this included a small section of wall to the top of the stairs left side front external wall.

- 1/. Hack-off and remove existing plaster from the areas indicated on the attached sketch to 1m high and floor to ceiling height where detailed on the plan and to the small area to the left side at the top of the stairs, and clear resultant debris from site.
- 2/ Install a chemical damp proof course incorporating our Diffusion Process to those walls indicated on the sketch to enable us to issue a guarantee. Our damp-proof course can be installed (subject to access) in solid walls from one side only of the wall to be treated, causing the minimum of disturbance.
